LCDOT WILSON & NIPPERSINK INTERSECTION WIDENING

SENSITIVE OUTFALLS & MANAGING EROSION

WILSON RD & NIPPERSINK RD INTERSECTION WIDENING (GRANT TOWNSHIP & ROUND LAKE)

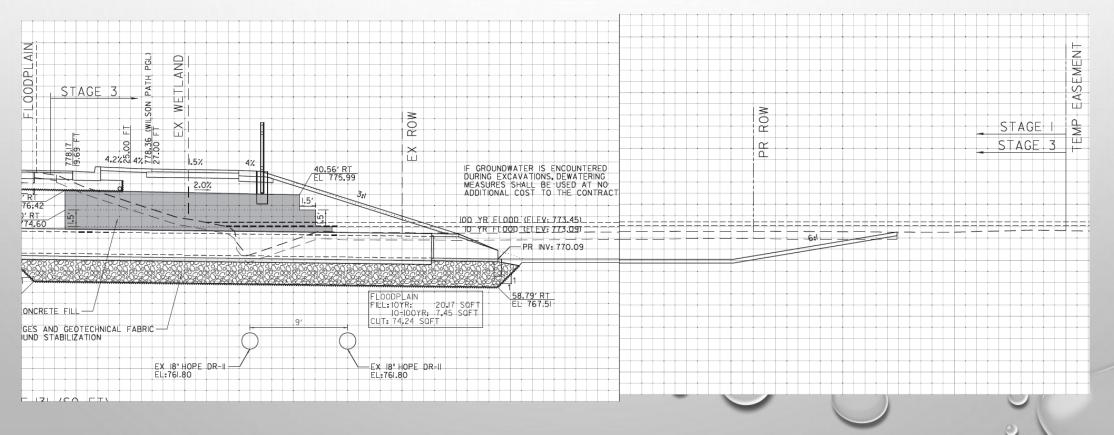
- THE SITE IS ESSENTIALLY A BOWL
 - ONLY WHEN THE BOWL IS FULL DOES WATER LEAVE THE SITE (OVERFLOW)
 - SITE HAS WATER ALMOST ALL YEAR ROUND
 - RARELY DID THE SITE GO DRY FROM EVAPORATION OR SOIL INFILTRATION

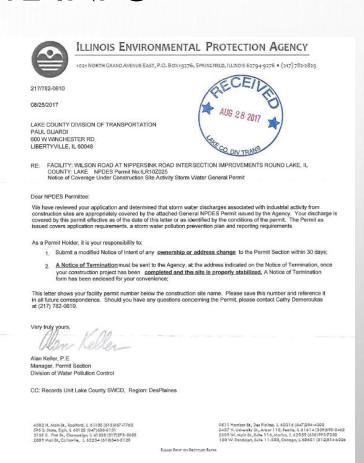
PERMITTING & SITE INFO

- IEPA NPDES PERMIT: ILR10Z025
- ARMY CORPS PERMIT
- WETLAND IMPACT
- BUILD COMPENSATORY STORAGE
- TOTAL AREA DISTURBED: 11.35 ACRE
- PROJECT START: 1/24/2018
- PROJECT END: 10/16/2019

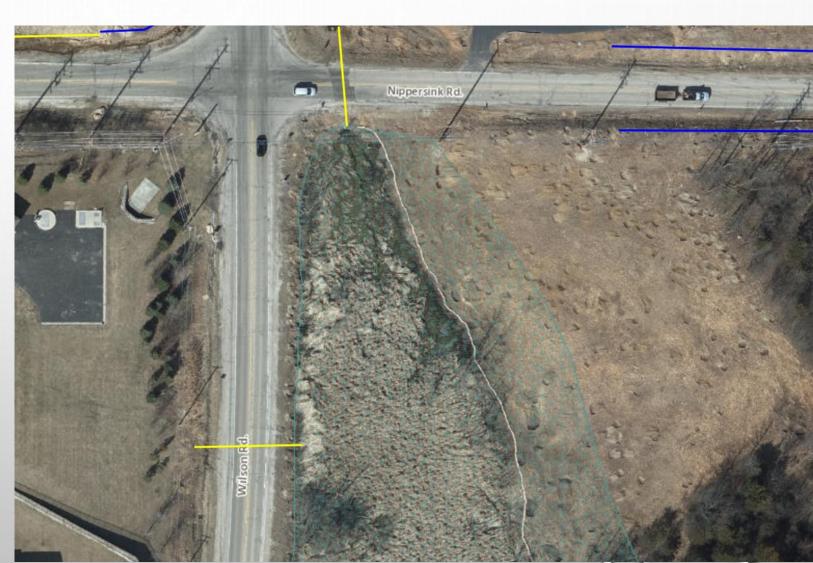
COMPENSATORY STORAGE TREE REMOVAL – EROSION CONTROL

- AREA GETS EXCAVATED
- BECOMES COMPENSATORY AREA
- LARGE AREA WHERE TREES WERE REMOVED
- AREA DIRECTLY FLOWS TO WETLAND
- SILT FENCE PLANNED BUT GROUND FROZEN
- INSTALLED EXCELSIOR LOGS
 - POUND STAKES IN / SCRAPE EARTH
 - CAN SEE LOGS IN AERIAL PHOTO

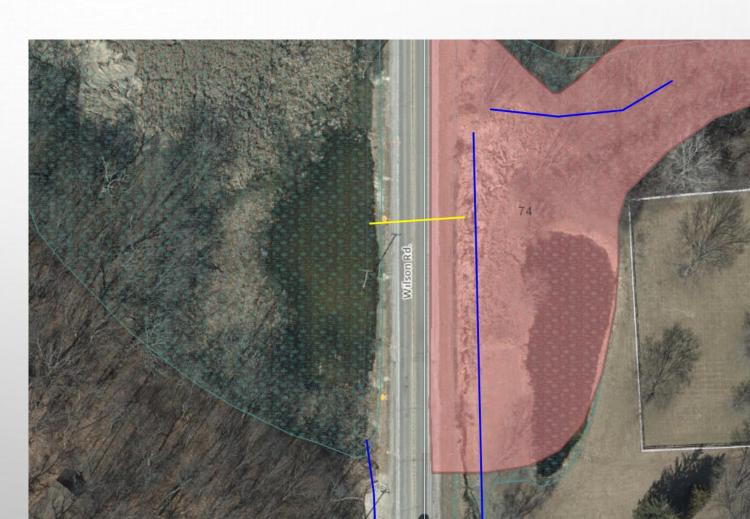
WIDENING WILSON SOUTHBOUND

- RIGHT-OF-WAY LINE IN WATER
- DUE TO RAINS, RARELY DRIED UP
- PLAN WAS TO PLACE SILT FENCE AND BUILT EARTHEN BERM
- COULD NOT INSTALL SILT FENCE IN 1'+ OF WATER
- NEEDED A DIFFERENT EROSION BARRIER TO PROTECT WETLANDS

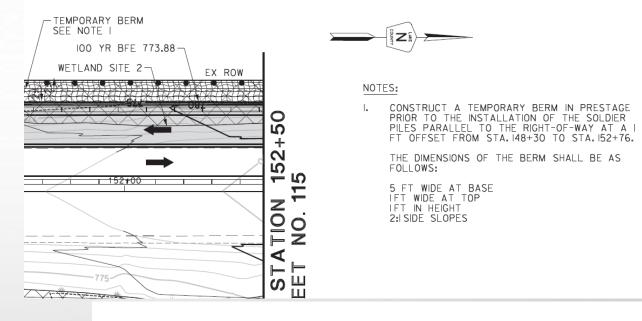
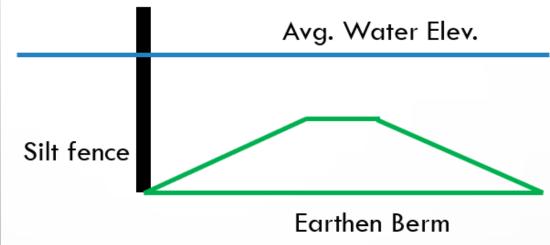
SILT FENCE & EARTHEN BERM

- PLAN CALLED TO INSTALL SILT FENCE ALONG
 THE ROW
- PLAN CALLED FOR THE CONSTRUCTION OF AN EARTHEN BERM BEHIND THE SILT FENCE TO KEEP WATER OUT
- ISSUES
 - WATER ALWAYS SITTING IN SILT FENCE LOCATION
 - WATER IS PART OF WETLAND AREA
 - TRENCHING IN SILT FENCE WOULD HAVE CLOUDED WATER AND ALLOWED SEDIMENT TO LEAVE THE SITE
 - BERM LIKELY WOULD HAVE BEEN TOO SHORT

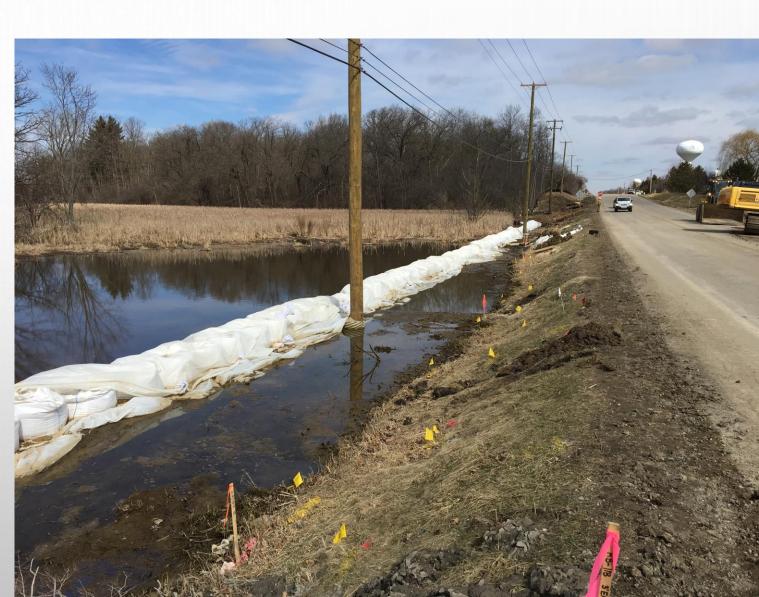
- AROUND 200 SANDBAGS USED
- PLACED ON & WRAPPED IN THICK PLASTIC
 TO MAKE THEM WATERTIGHT
- ALLOWED FOR MINIMAL DISTURBANCE IN THE WETLAND AREA
- EASILY REMOVED (AFTER 1.5 YEARS)
- PREFERRED OVER SILT FENCE/BERM & SILT CURTAIN OPTION
 - PROVIDES A STABLE WATERTIGHT BARRIER
 - PROVIDES AN ARMOR AND LITTLE NEED FOR REPAIRS
 - REPAIRS COULD LIKELY LEAD TO A LOSS OF SEDIMENT

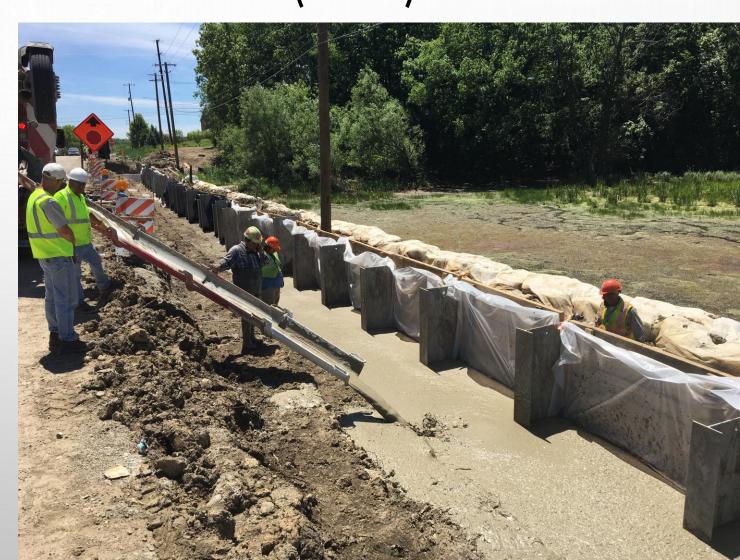
PROTECTING WETLANDS FROM LIGHTWEIGHT CELLULAR CONCRETE FILL (LCCF)

- GROUT MIX WITH FOAM MIX USED TO STABILIZE POOR SOILS FOR VEHICLE LOADING
- VERY THIN MATERIAL THAT CAN TRAVEL
 THROUGH SMALL HOLES AND CRACK
 - USED PLASTIC, DUCT TAPE, BACKER ROD
 & GREAT STUFF TO SEAL
- CONTRACTOR PROVIDED A WATCH & PROTECT PERSON FOR LEAKS BEHIND THE WALL

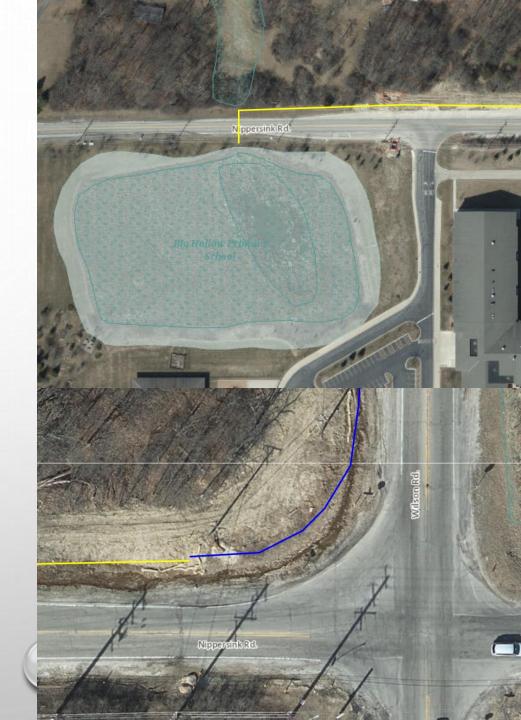
BIG HOLLOW SCHOOL RUNOFF

- LARGE WETLAND AREA
- WATER RELEASED SLOWLY VIA RESTRICTOR STRUCTURE
- PROVIDED A CONSTANT CONCENTRATED FLOW INTO THE SITE
- FLOW WOULD EXIT PIPE IN NW CORNER AND FREE
 FLOW AROUND TO THE NORTH
- NEW STORM SEWER INSTALLED HOLD FLOW AROUND CORNER AND THEN RELEASE IN TO STABILIZED DITCH
- WATER WAS REDIRECTED FOR A PERIOD OF TIME BECAUSE THE FLOW WAS TOO HEAVY

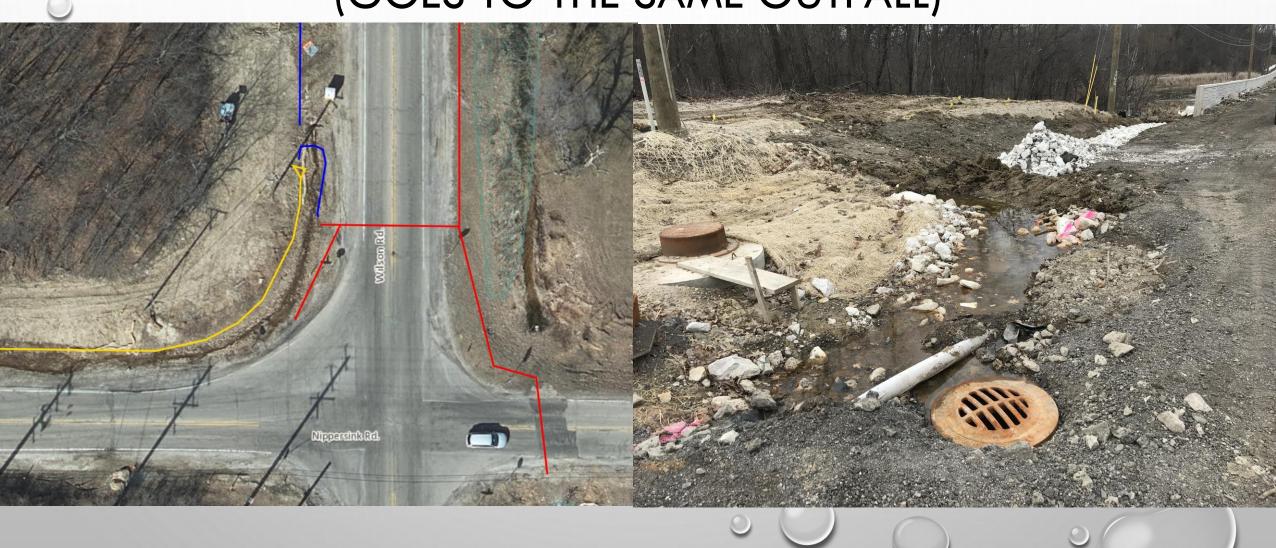
BYPASS INTO OTHER STORM SEWER SYSTEM (GOES TO THE SAME OUTFALL)

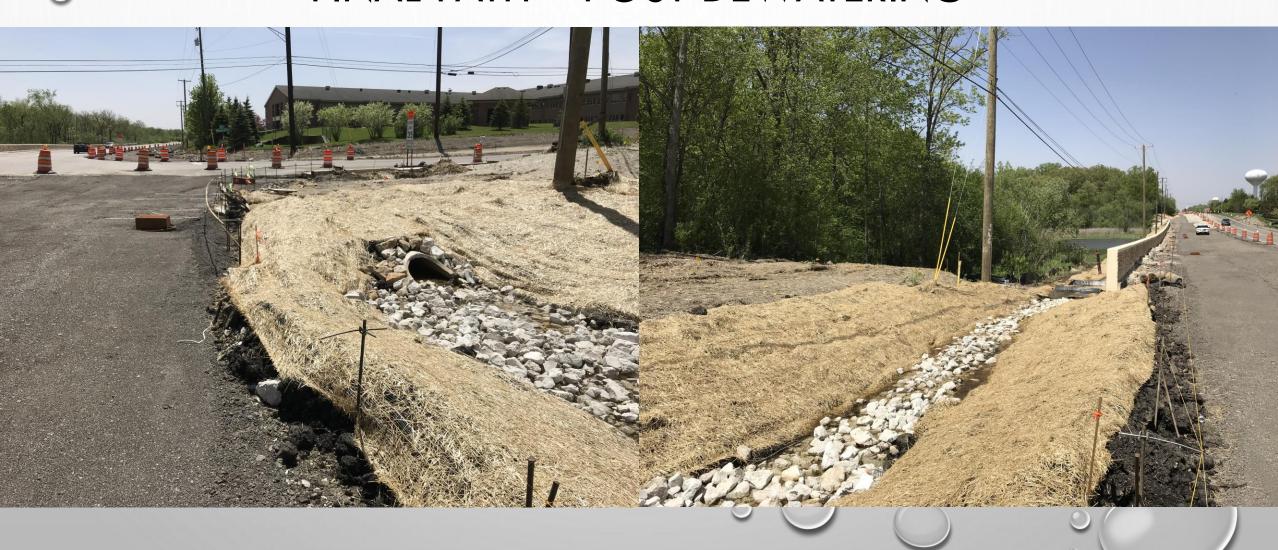
FINAL PATH - POST DEWATERING

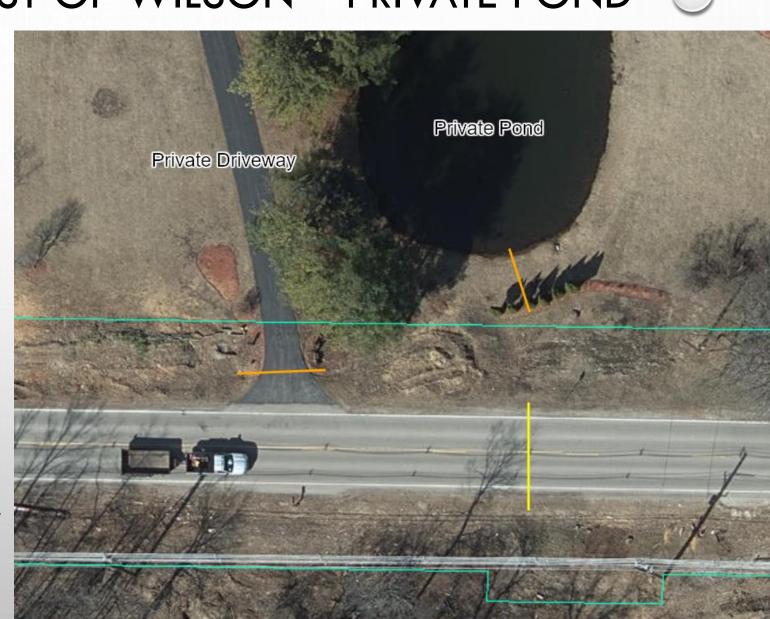
NIPPERSINK RD EAST OF WILSON - PRIVATE POND

- EXISTING NIPPERSINK CROSS CULVERT
 - OLD, FULL OF SEDIMENT & ALLOWED
 SLOW DRAINAGE TO THE NORTH
 - CAUSED A BUILD UP OF WATER ON THE SOUTH SIDE OF THE ROADWAY
 - LARGE TRIBUTARY AREA TO THE SOUTH
 - RECEIVES SOUTH SIDE DITCH WATER
 FROM TOP OF HILL
- SMALL EXISTING CULVERT FROM NORTH
 SIDE DITCH TO PRIVATE POND
 - RECEIVES WATER FROM CROSS CULVERT,
 SOUTH SIDE DITCH & NORTH SIDE DITCH

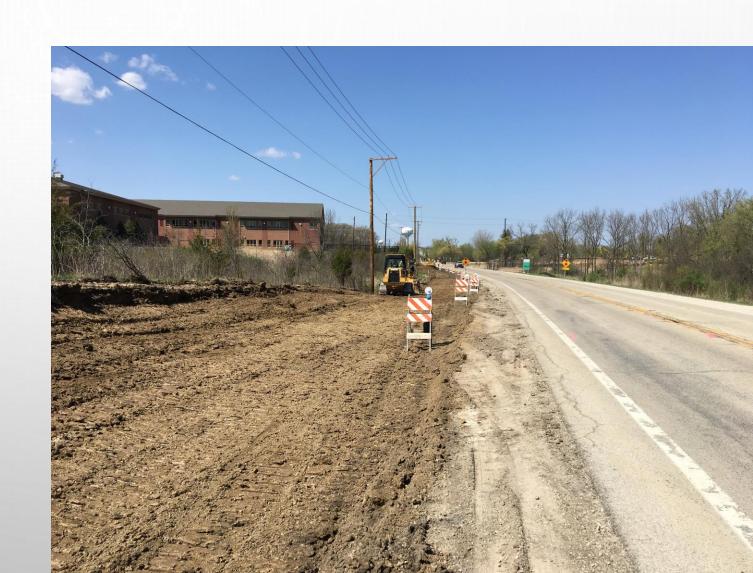
PREPPING FOR TEMPORARY PAVEMENT

- EXCAVATE EXISTING SHOULDERS
- LARGE BARE CLAY AREAS
- COMPACT AND GRADE BEFORE
 INSTALLING TEMPORARY AGGREGATE
 BASE
- SITE'S MOST VULNERABLE STAGE
- ALL BMP'S SPECIFIED IN PLACE

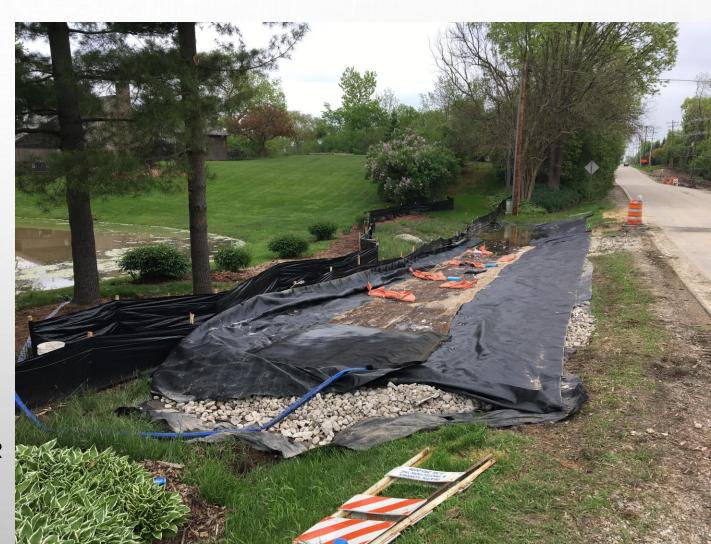
REMEDIATION OF THE PRIVATE POND

- CONTACTED RESIDENT & KEPT THEM INVOLVED THROUGH ENTIRE PROCESS
 - WEEKLY CONTACT (PHONE, EMAIL, IN-PERSON)
- OBTAINED A RIGHT-OF-ENTRY PERMIT
- PROPER DOCUMENTATION
 - DIARY, FIELD BOOK, SWPPP/DECI REPORT, IEPA ION & CONTACT LCSMC
- SITE WAS IN VULNERABLE SPOT, BUT NO EXCUSE FOR WHAT HAPPENED.
- DETERMINE ADDITIONAL BMP'S TO BE INSTALLED
- INSTALL A TREATMENT TRAIN & RUN UNTIL WATER IS CLEAR

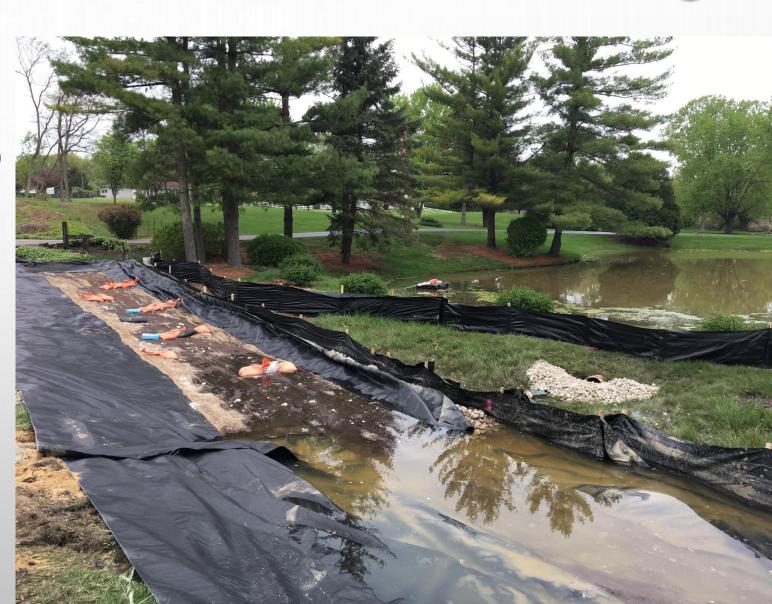
TREATMENT TRAIN

- INTAKE WATER FROM POND (FLOATING HOSE ATTACHED TO PUMP)
- SILT BAG
- FLOC LOG & POWDER
- EROSION CONTROL MAT (JUTE YARN)
- SANDBAGS (CREATE TURBULENCE)
- BASIN FOR SETTLEMENT
- RETURN TO POND
- ***RUN UNTIL WATER IS CLEAR

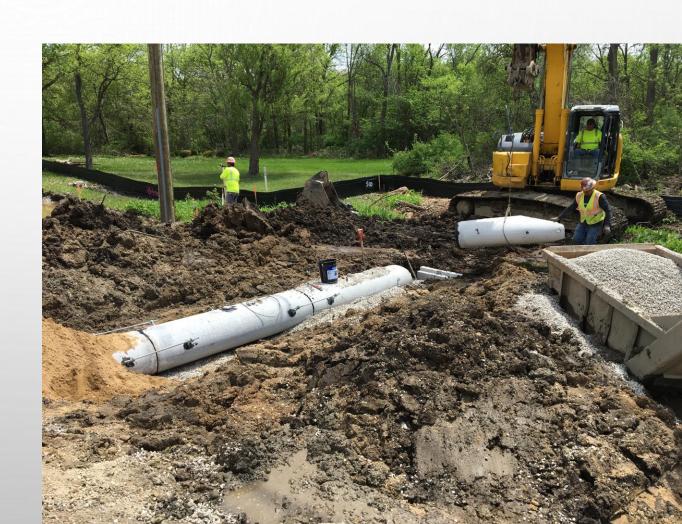
- IN ORDER TO BUILD THE TEMPORARY ROADWAY
 A NEW CROSS CULVERT WAS TO BE INSTALLED
- NEW CROSS CULVERT MADE US PAY SPECIAL ATTENTION TO DRAINAGE AND EROSION CONTROL IN THIS AREA
- WATER IN THIS LOCATION COMES INTO THE CONSTRUCTION AREA AND EXITS RAPIDLY
- MAKES FOR DIFFICULTY CONTROLLING EROSION BECAUSE THERE IS LITTLE TIME TO FILTER THE WATER
- LARGE AMOUNTS OF WATER MAKES IT DIFFICULT TO HOLD ANY WATER BACK

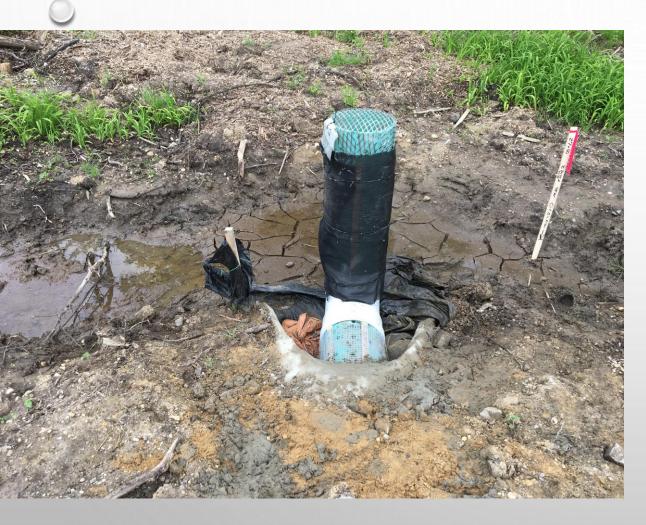
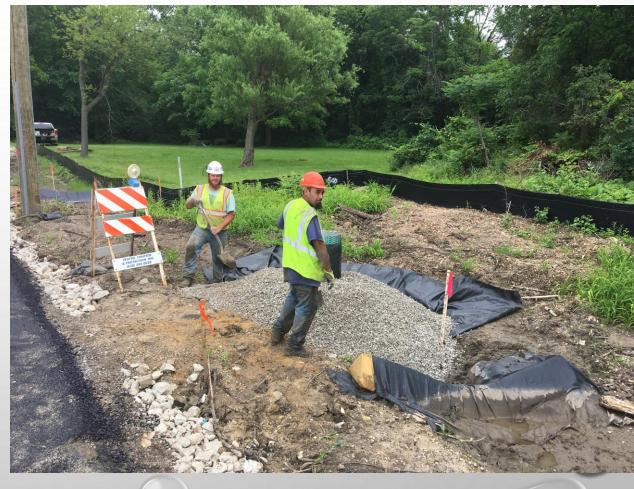
PERFORATED RISER

- CA-7 (WASH STONE) PILED AROUND RISER
- RIPRAP INSTALLED AROUND RISER
- TEMPORARY SEED & BLANKET INSTALLED IN TRIBUTARY DITCHES
- TEMPORARY AGGREGATE AND ASPHALT IN PLACE PROVIDING COVER
- DITCH CHECKS INSTALLED
- FLOC LOG INSTALLED IN RISER PIPE

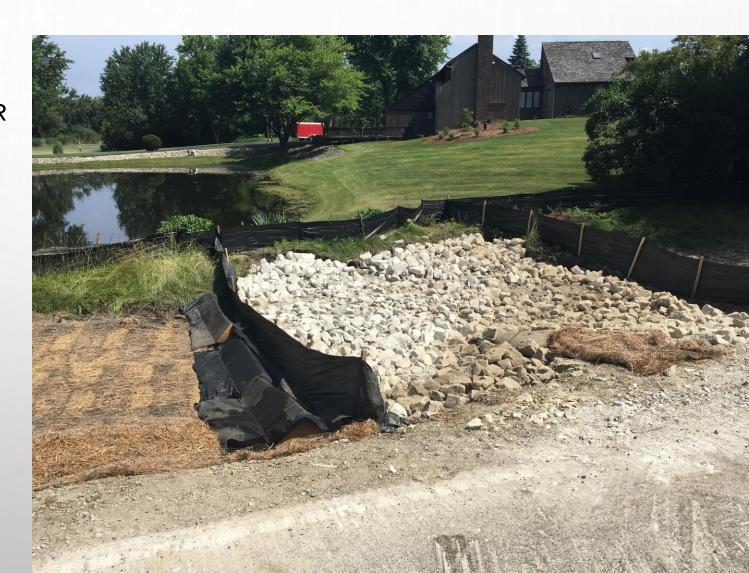
AREA ADJACENT TO PRIVATE POND

- RIPRAP INSTALLED
- DITCH CHECKS INSTALLED TO SLOW WATER
- SILT FENCE INSTALLED BEHIND DITCH CHECKS TO ACT AS A SORT OF SILT CURTAIN
 - KEEP SOUTH WATER AND NORTH WATER SEPARATED
- TEMPORARY SEED & BLANKET INSTALLED
- FLOC LOGS INSTALLED AT FLARED-END-SECTION & AT ENTRANCE TO SMALL PIPE THAT LEADS TO POND

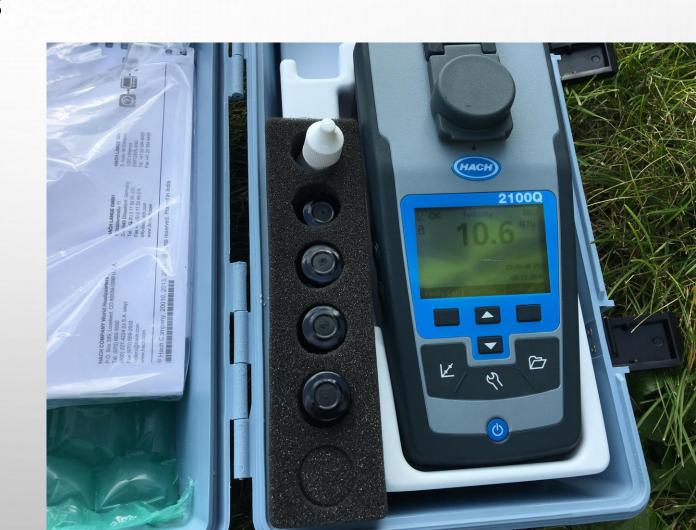
- SHORTLY AFTER STABILIZING AREA, DISCHARGES
 WERE NOT ALWAYS COMPLETELY CLEAR
- ON THE FENCE IF AN ION WAS NEEDED
- PRIVATE POND WAS CONSIDERED PART OF SITE DUE TO THE R.O.E. BUT STILL A SENSITIVE AREA WHERE SEDIMENT CANNOT ENTER
- CONTACTED LCSMC FOR GUIDANCE
 - SUGGESTED TURBIDITY METER USE TO MONITOR DISCHARGES
 - 10 IS VERY CLEAN AND SHOULD NOT WORRY
 - 50 BEGINS TO BECOME QUESTIONABLE
 - USE AS A TOOL TO HELP YOUR DECISION

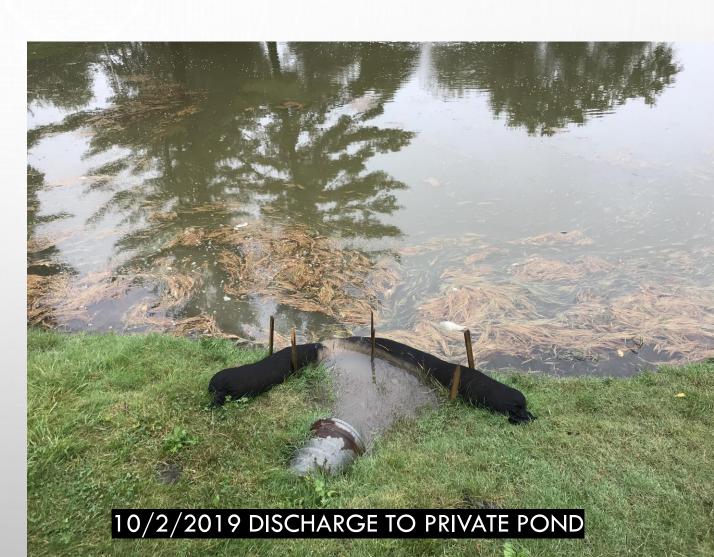
TURBIDITY METER - SAMPLE RESULTS

- TEST ON 9/21/2018
 - 11.2 NTU, 10.6
- TEST ON 10/2/2018
 - 92.9 NTU IN RIPRAP BEFORE POND
 - 50.3 NTU & 82.8 NTU IN POND
 - ***IEPA ION SUBMITTED
 - TURBIDITY METER AIDED IN DECIDING WHETHER
 TO SUBMIT ONE
- TEST ON 10/31/2018
 - 32.6 NTU, 20.9 NTU, 7.55 NTU
- TEST ON 1/8/2019
 - 5.57 NTU, 5.64 NTU, 4.63 NTU

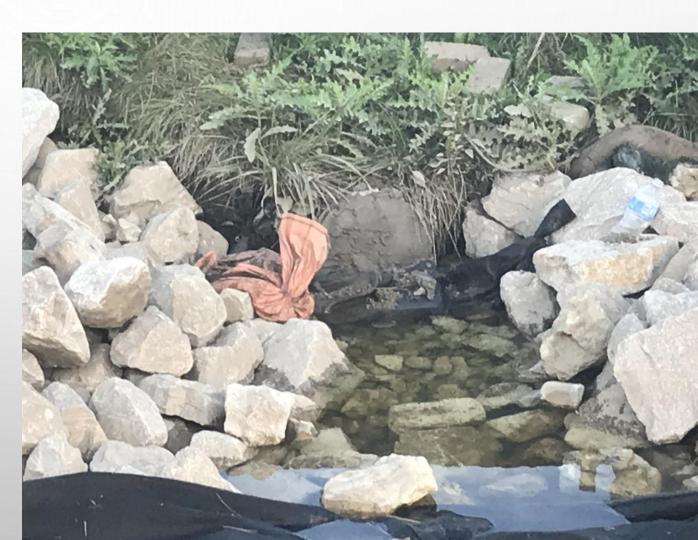
POST 10/2/2019 ION – BMP CHANGES

- SILT CURTAIN AND EXCELSIOR LOG AT DITCH-TO-POND PIPE OUTLET
- BRICK & MORTAR NORTH SIDE OF CULVERT TO HOLD WATER BACK
- INCREASE RIPRAP AREA ON SOUTHSIDE FOR MORE STABILIZATION
- CONTINUE TREATMENT TRAINS
 - MULTIPLE DIFFERENT TYPES
- BRICK AND MORTAR THE DITCH-TO-POND PIPE SHUT
 - HOLD ALL RUNOFF WATER IN DITCH
 - WAIT FOR SEDIMENT TO FALL OUT OF SUSPENSION
 - PUMP CLEAR WATER INTO POND AND PREPARE FOR NEXT RAINFALL EVENT

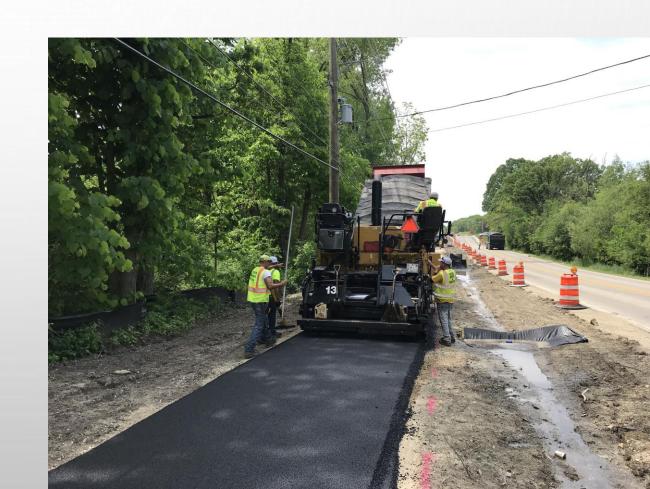
- SHARED-USE PATH GETTING PAVED
- SHARED-USE PATH PAVED AND READY FOR FINAL LANDSCAPING
- NEED TO AVOID ANY MORE ION'S
- DEPENDING ON WEATHER, GRASS MAY NOT GROW WELL IN AREAS TRIBUTARY TO POND
- WATER COMES ROARING DOWN FROM THE TOP OF THE HILL

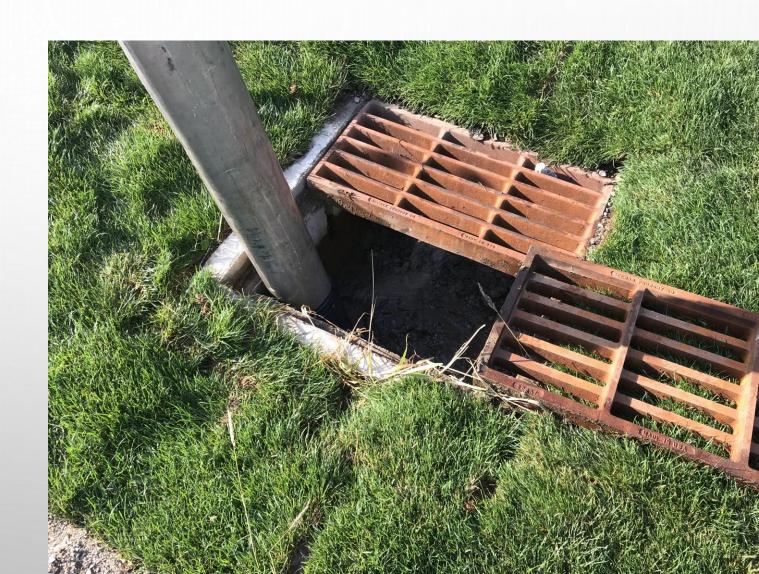
FINAL PREPARATIONS & CLEANING

- AREA HAS BEEN STABILIZED
- LET WATER FLOW DIRECTLY INTO POND
- NEED TO CLEAN WHERE WATER RUNS
 - STORM SEWER
 - RIPRAP
 - CULVERT
- REMOVE TEMPORARY BMP'S

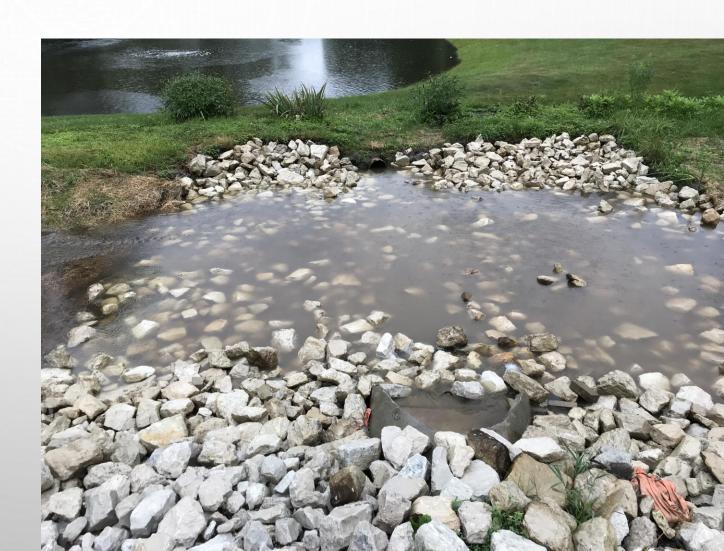
ASSURANCE THAT IT WORKED

- CHECKED DURING RAINFALL EVENT THAT DISCHARGE WAS CLEAR FROM SITE INTO PRIVATE POND
- PICTURE TAKEN ON 7/18/2019 DURING
 HEAVY RAINFALL EVENT
- REPORT ISSUED FOR EVENT SHOWED 2.71
 INCHES OF PRECIPITATION

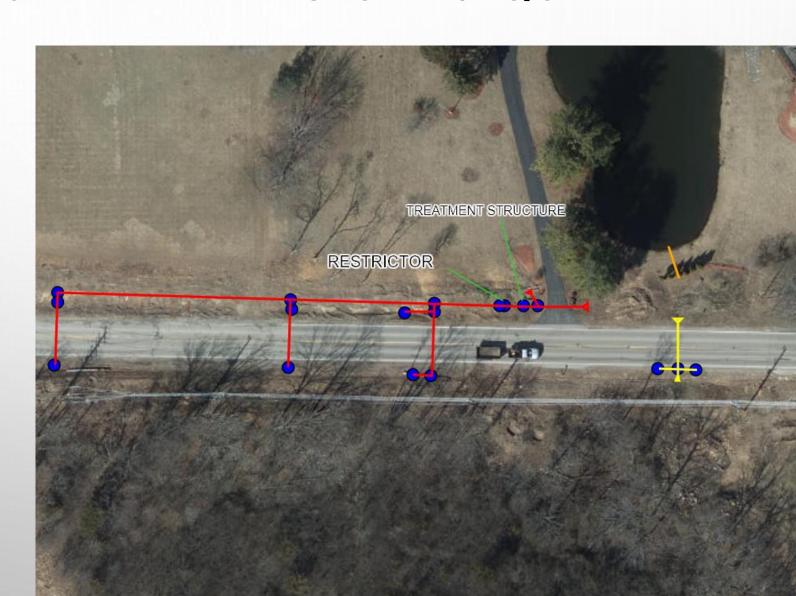
STORM SEWER SYSTEM WATER VOLUME & QUALITY

- ROADWAY WIDENED AND WATER
 RUNOFF NO LONGER SPLIT B/T DITCHES
 - ALL WATER PUT INTO SYSTEM AND CONCENTRATED
- RESTRICTOR STRUCTURE USED TO SLOW THE FLOW OF WATER
- WATER PROCESSED THROUGH CONTECH TREATMENT STRUCTURE
 - SEPARATES SOLIDS OUT
 - TWO TYPES OF TREATMENT DEPENDING ON VOLUME OF FLOW
- RESTRICTOR AND TREATMENT STRUCTURE MITIGATE THE CONCENTRATED STORM WATER

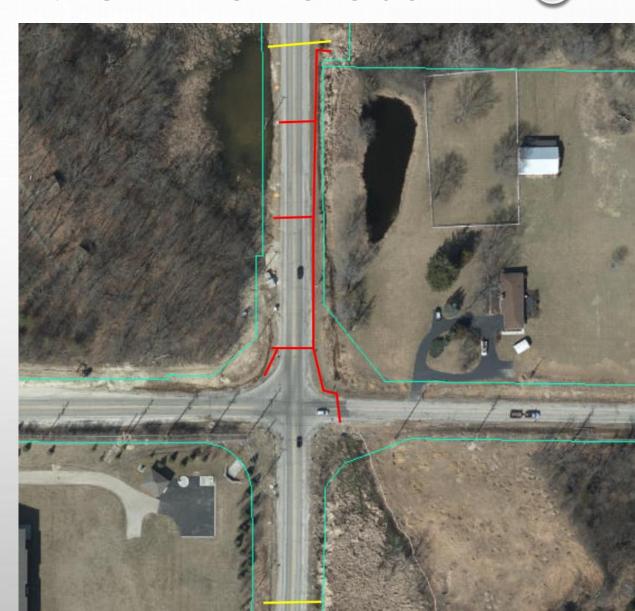
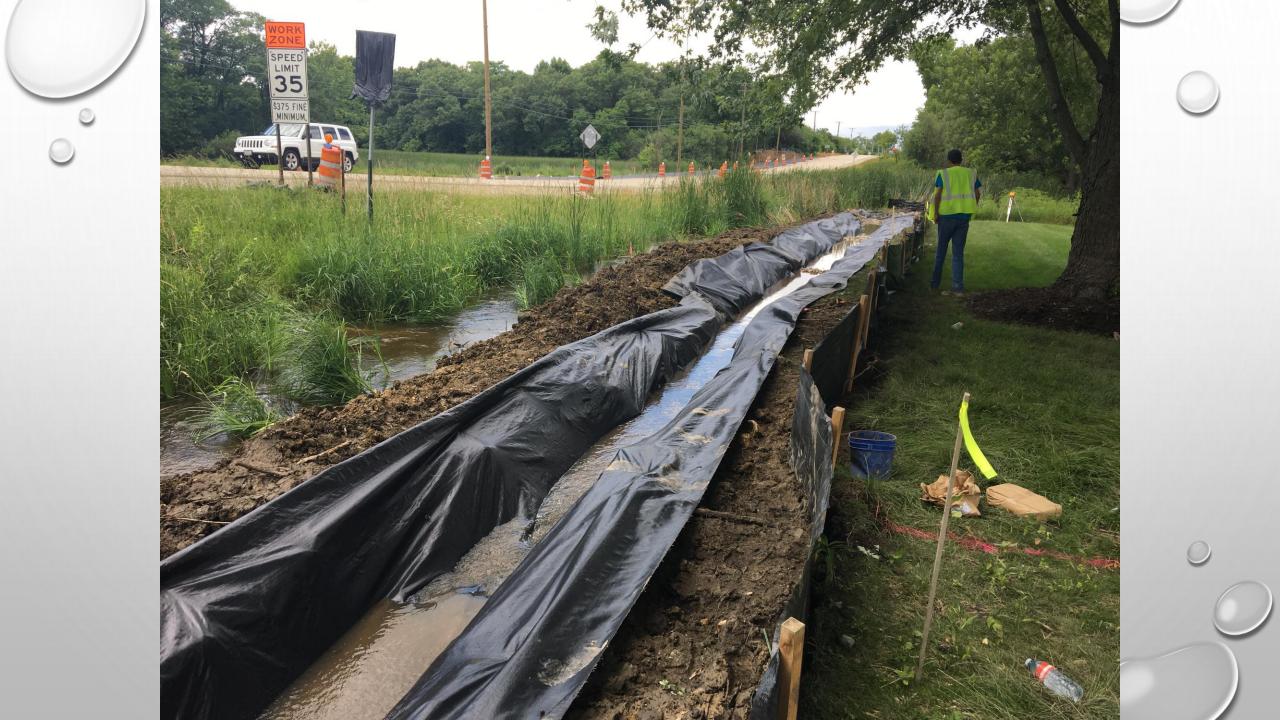
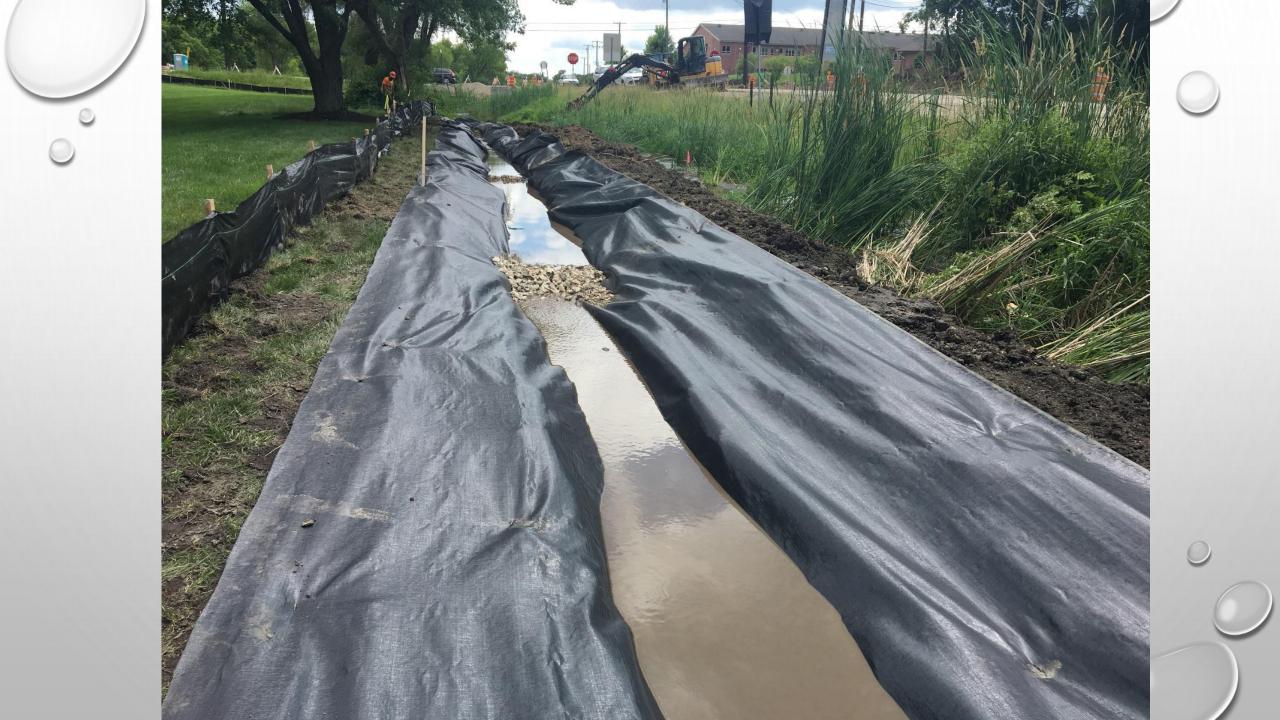
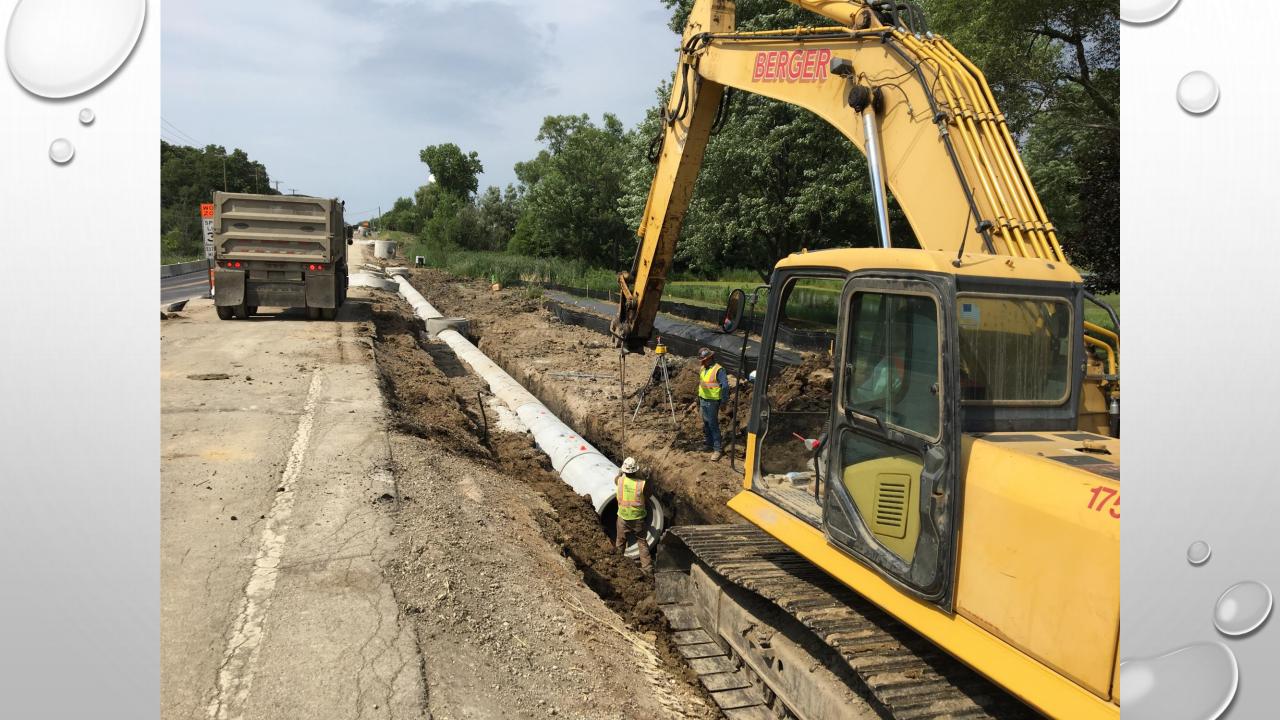
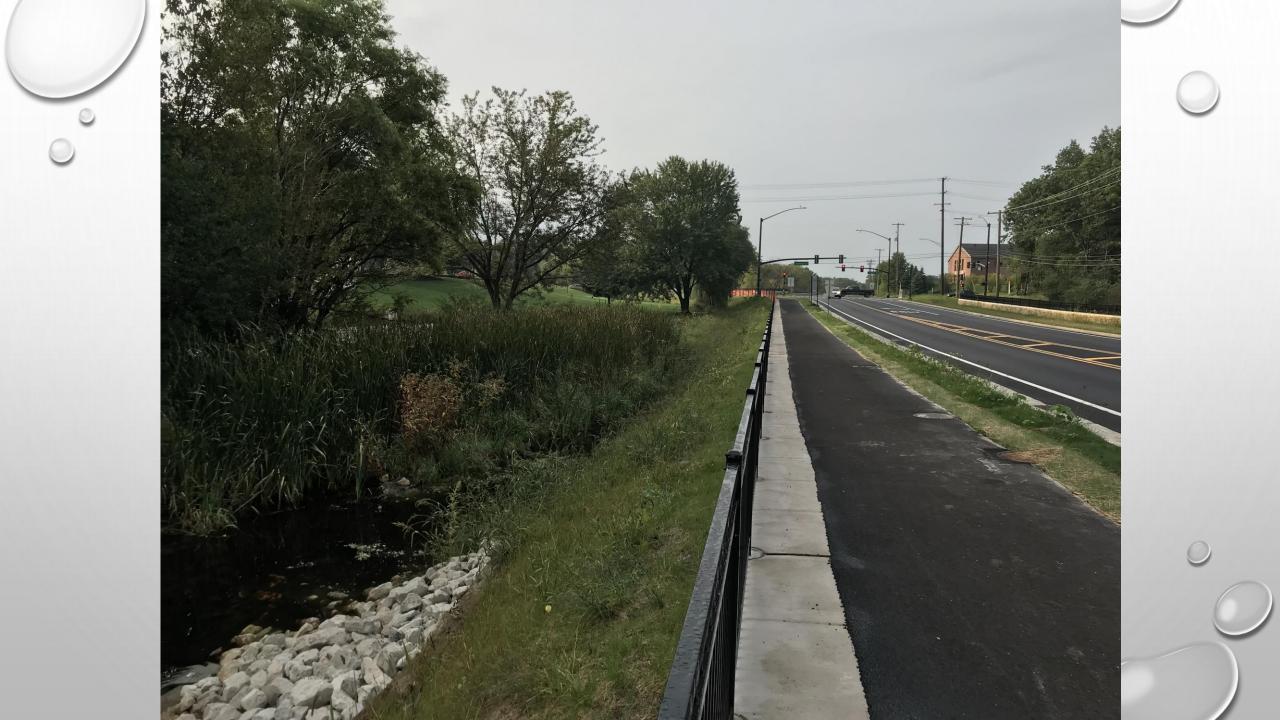
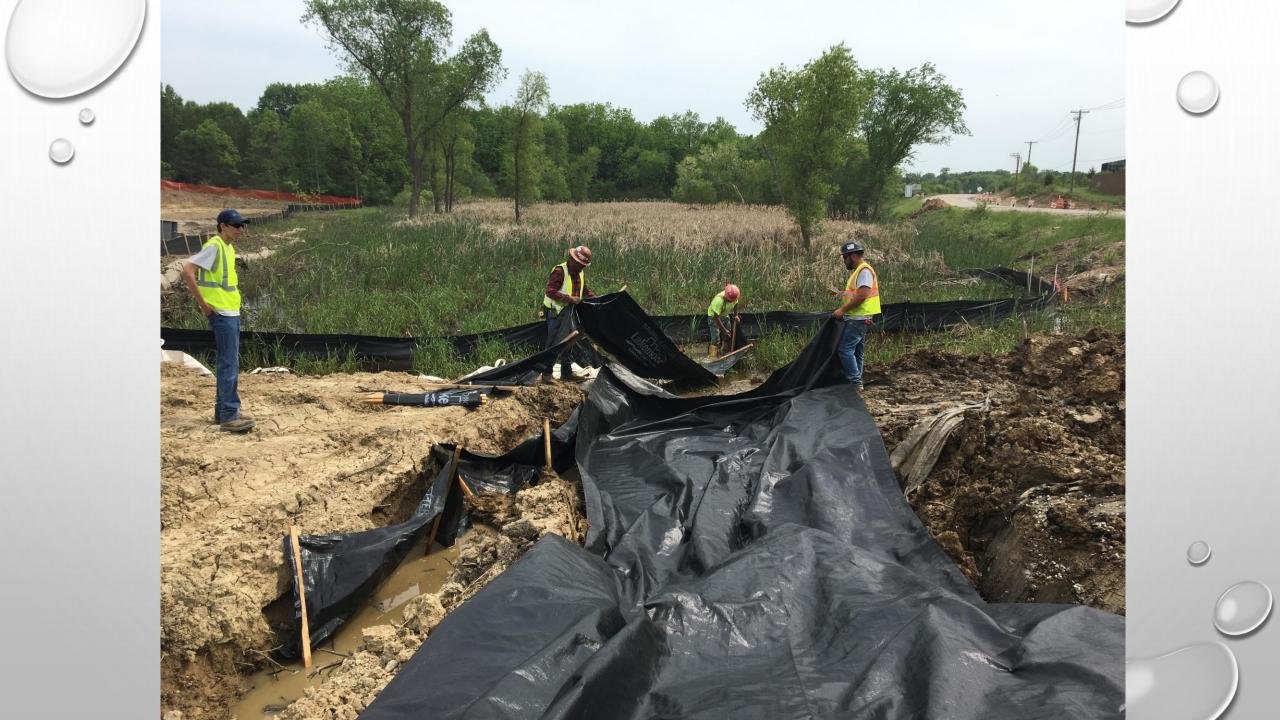
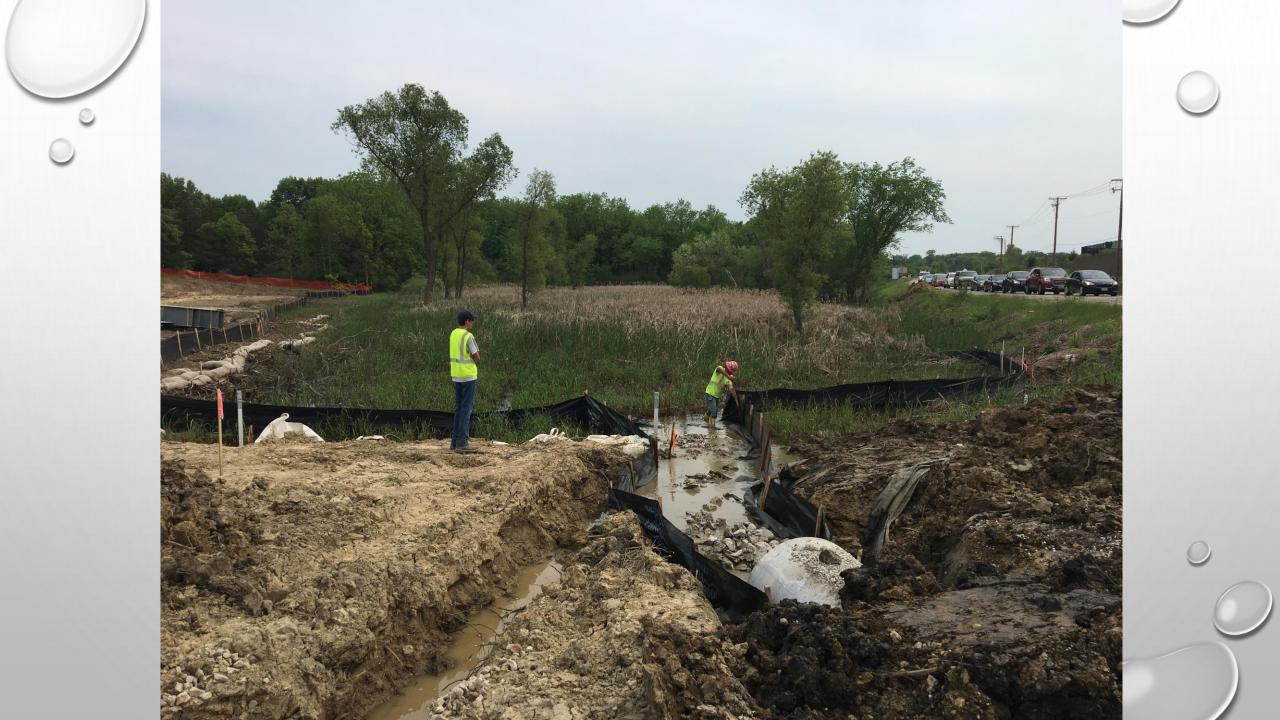
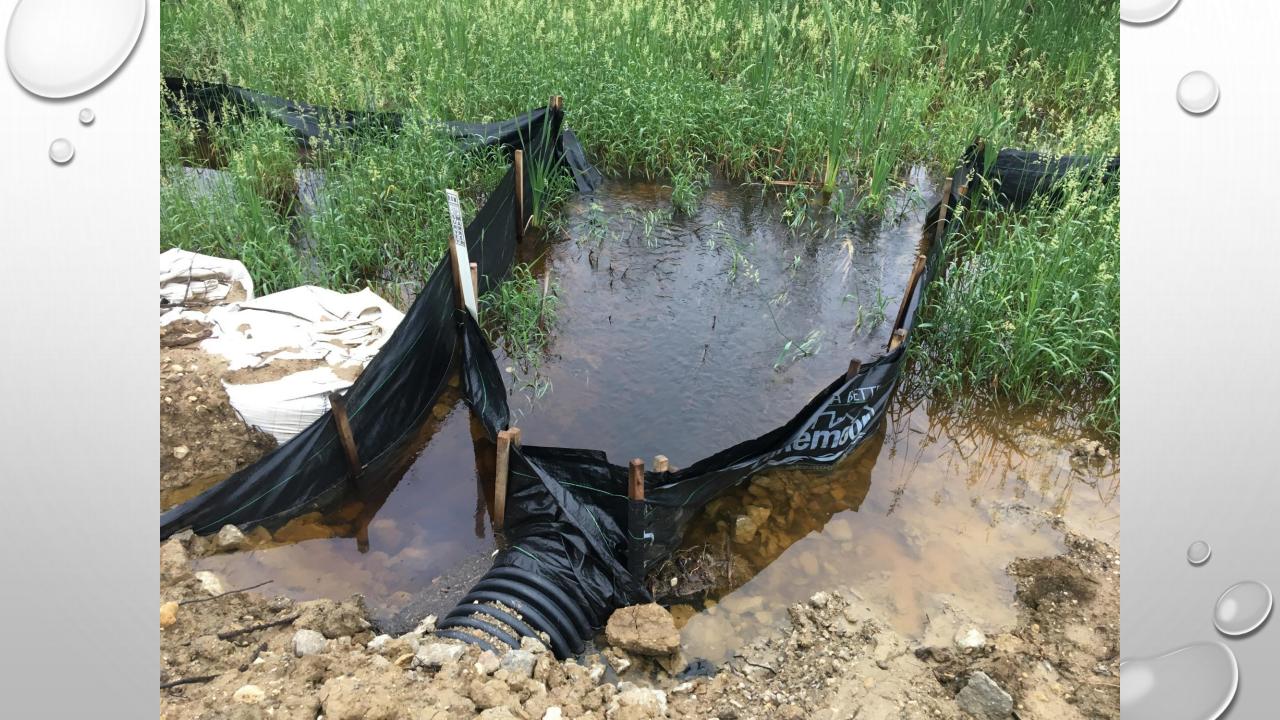
EAST SIDE WETLAND DRAINAGE DITCH CLOSURE

- SOUTHEAST CORNER WETLANDS DRAIN TO THE NORTH VIA CROSS CULVERT UNDER NIPPERSINK RD
- A LARGE OPEN DITCH ALLOWS WATER TO FLOW NORTH TO EVENTUAL OUTFALL TO THE EAST
- ROAD TO BE WIDENED AND SHARED-USE PATH TO BE INSTALLED WHERE DITCH IS
- PIPE THE DITCH SHUT IN ORDER TO BUILD ABOVE IT
- USE SILT FENCE & GEO FABRIC AT INFLOW TO KEEP WATER
 CLEAN
- TEMPORARY DITCH INSTALLED TO THE EAST FOR RUN-AROUND
 - LINED WITH GEO FABRIC
 - STONE DITCH CHECKS
 - FLOC LOGS
 - SILT FENCE ON BOTH SIDES

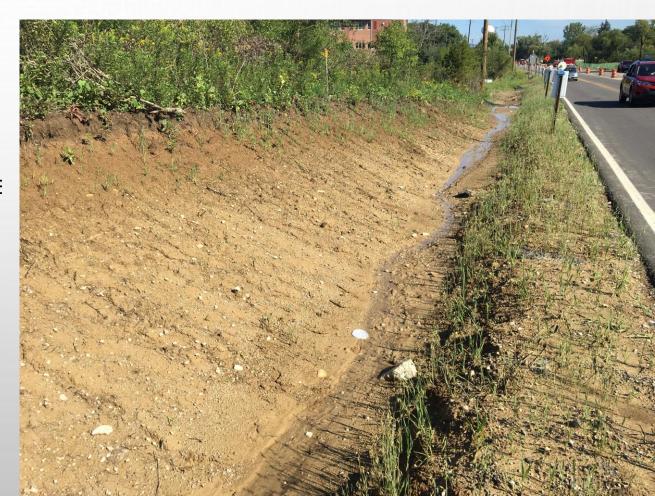
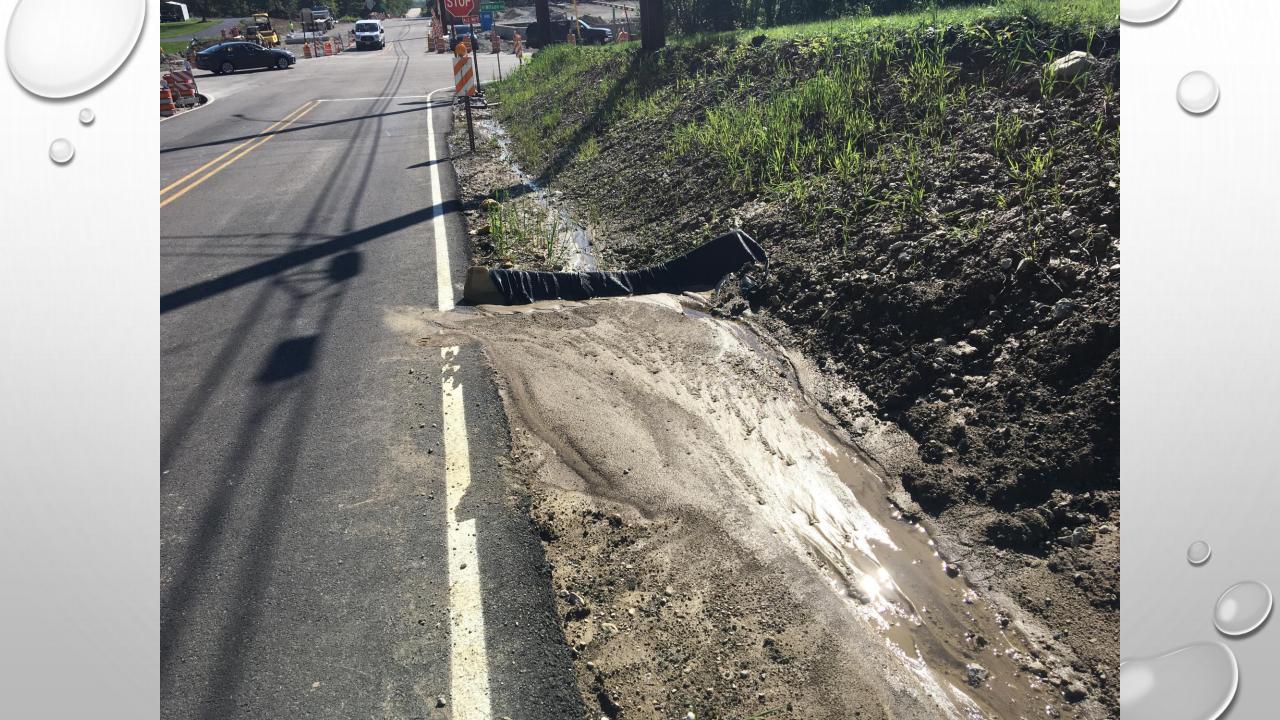
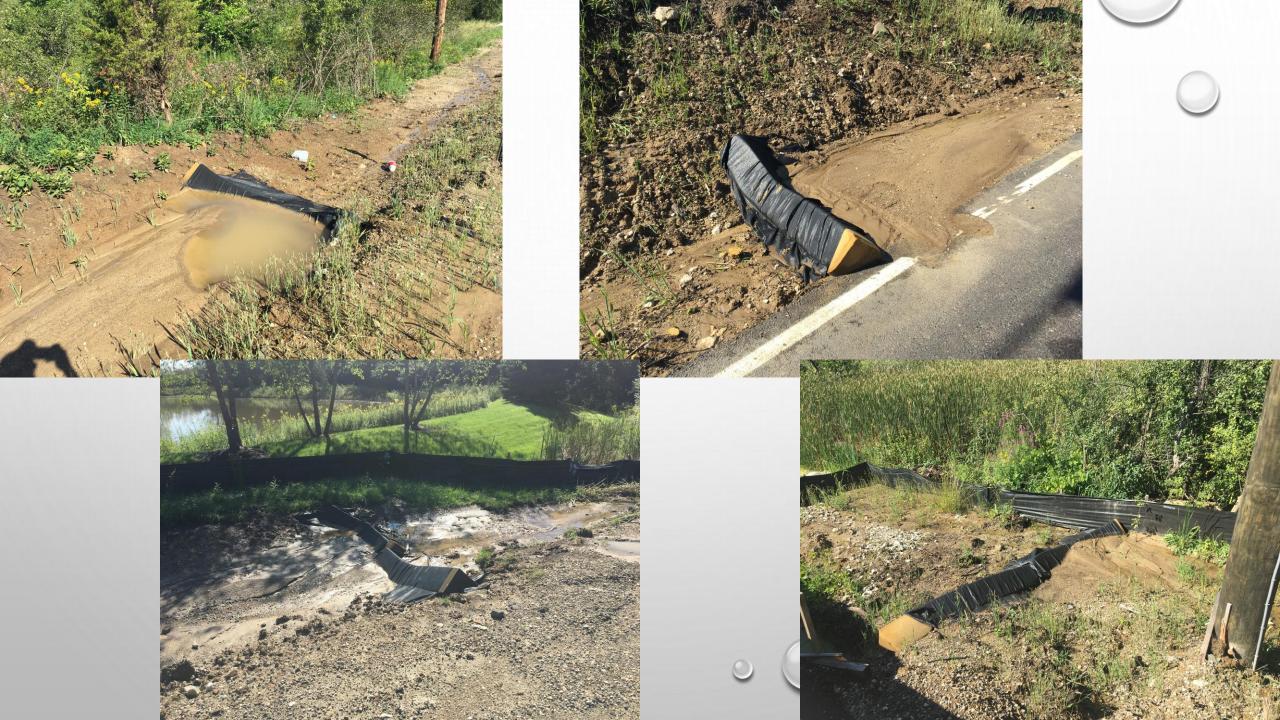
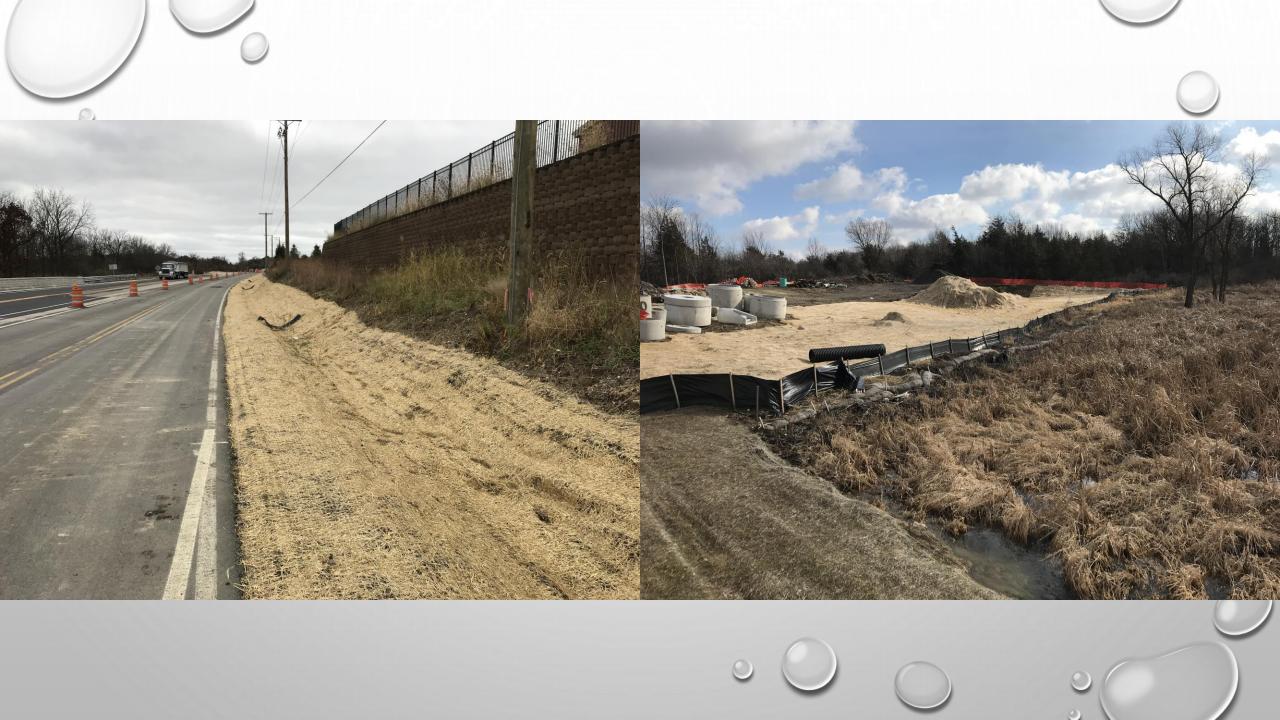
GENERAL PREPARATIONS FOR WINTER SHUTDOWN

- TEMPORARY DITCHES THROUGHOUT PROJECT ARE BARE CLAY WITH TEMP SEED
- PREPARE FOR SNOW MELT
- REGAIN/INCREASE CAPACITY IN TEMPORARY DITCHES
 - DUE TO ALL THE RAINFALL EVENTS SEDIMENT HAS BUILT UP IN DITCHES
 - RE-EXCAVATION NEEDED TO ALLOW PROPER DRAINAGE
 - TEMPORARY DITCH CHECKS WORKING BUT BEYOND CLEANING NEEDED
- INSTALLED TEMPORARY BLANKET IN ALL TEMPORARY DITCHES
- INSTALLED EROSION CONTROL MAT IN FLOW LINES
- PLACE FLOCCULATION POWDER ON EROSION CONTROL MATTING
